**66AK2Lxx**  
**Multicore DSP+ARM KeyStone II SOC**  
**Silicon Revision 1.0**

# Silicon Errata

Literature Number: SPRZ430

April 2015

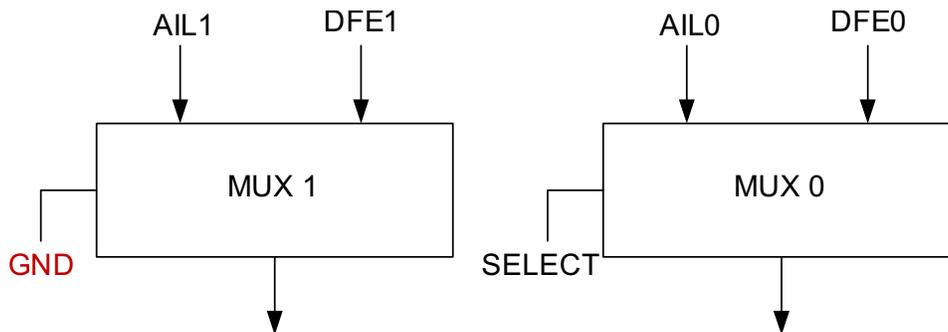
**Figure 2. AIL Lanes**

IQN2 has two AIL lanes (AIL0 and AIL1). AIL1 lane does not transmit or receive any data. AIL0 lane can transmit or receive data without showing any problem.

As shown in [Figure 2](#) below, the AIL0 and AIL1 lanes are connected to a SERDES MUX with respect DFE lanes. This SERDES MUX is used to select data path between IQN2 and DFE. The mux select for the AIL1 and DFE1 mux is not connected correctly and is connected to Ground. So DFE1 lane is always selected irrespective of the configuration selected by mux pins.

There is no SW workaround for this problem.
