# Chip Errata for the i.MX RT1064

This document details the silicon errata known at the time of publication for the i.MX RT1064 crossover processors.

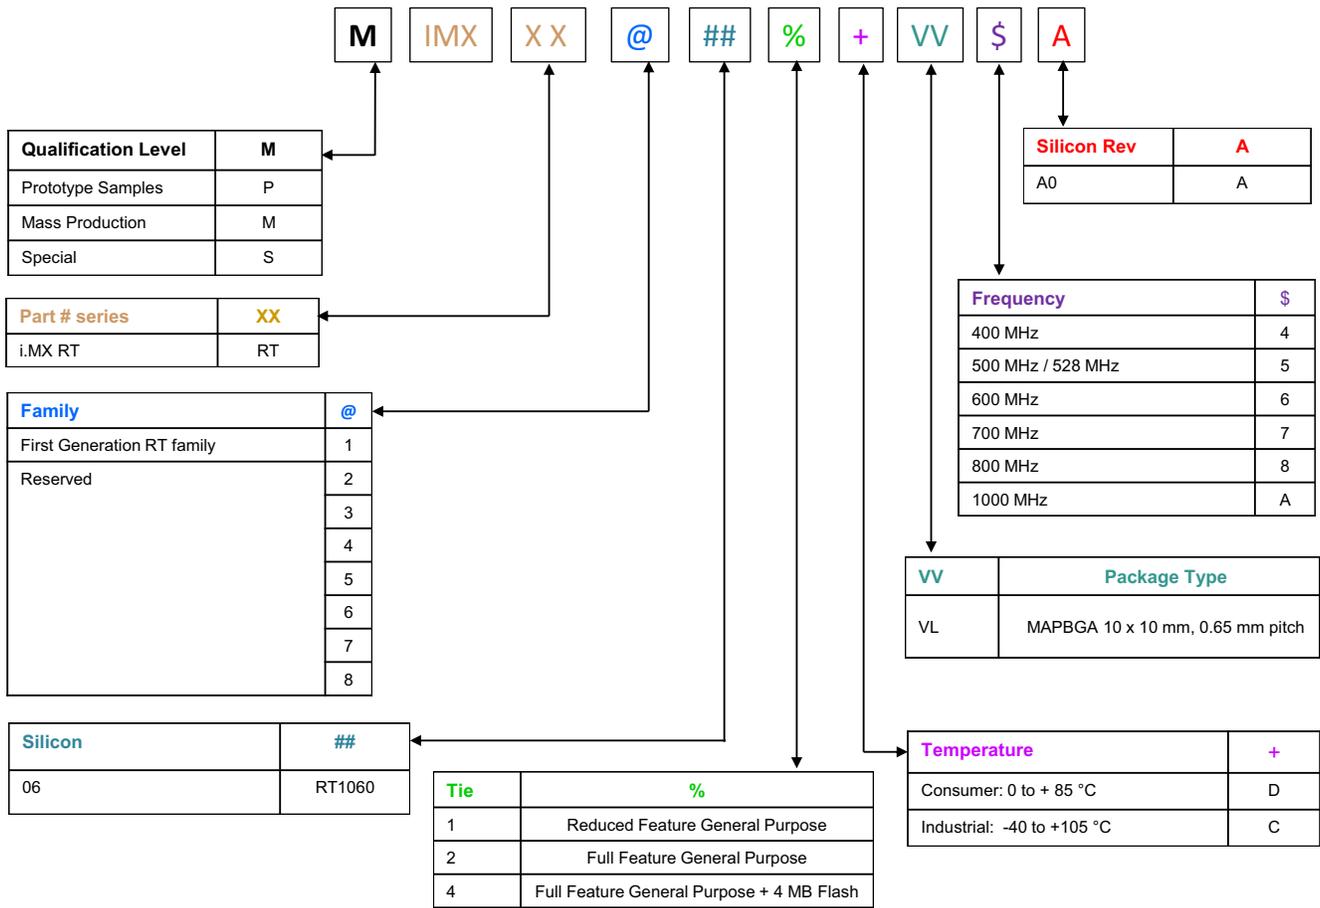
Figure 1. Revision Level to Part Marking Cross-Reference

Figure 1 provides a cross-reference to match the revision code to the revision level marked on the device.
